**Village Board of Trustees - Committee of the Whole**

**May 13, 2024**

a. Facility Condition Assessment and Deferred Maintenance Plan Report

# Village of Villa Park – Facilities Condition Assessment

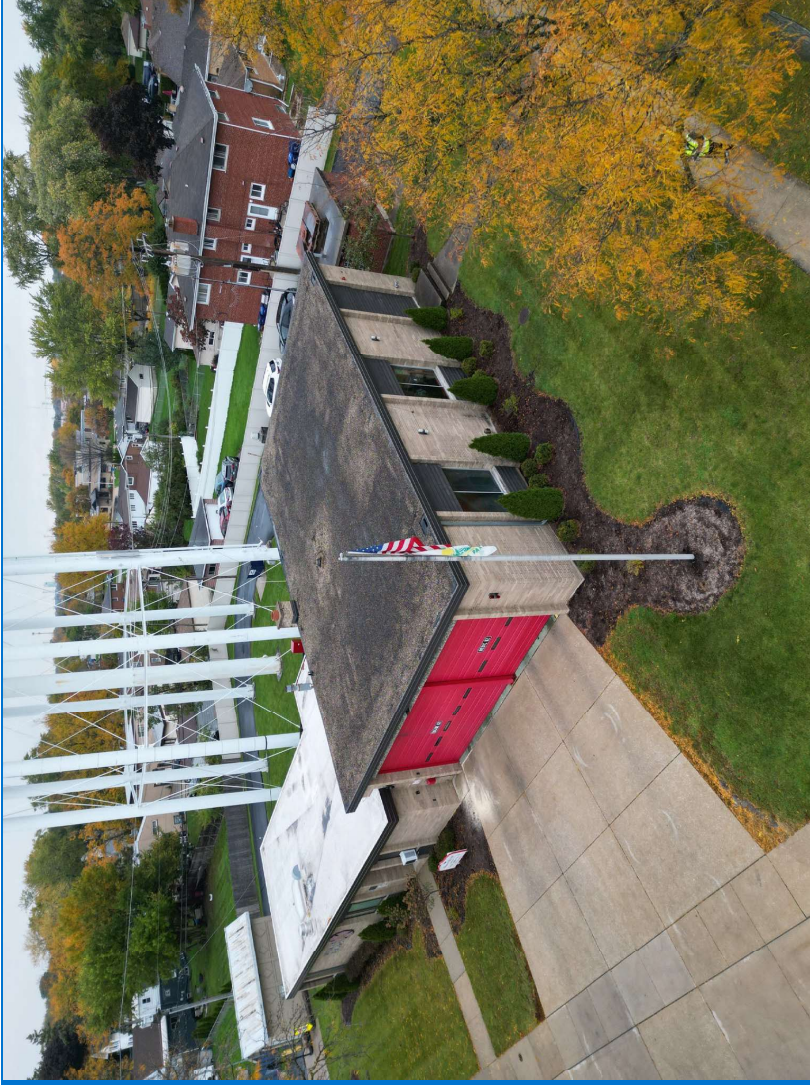
# Fire Station #82

- Built in 1967 (57 years old)
- \$393,083 of maintenance and repairs over the next 10 years identified.
  - Top three costs are: interior finishes, exterior and HVAC.

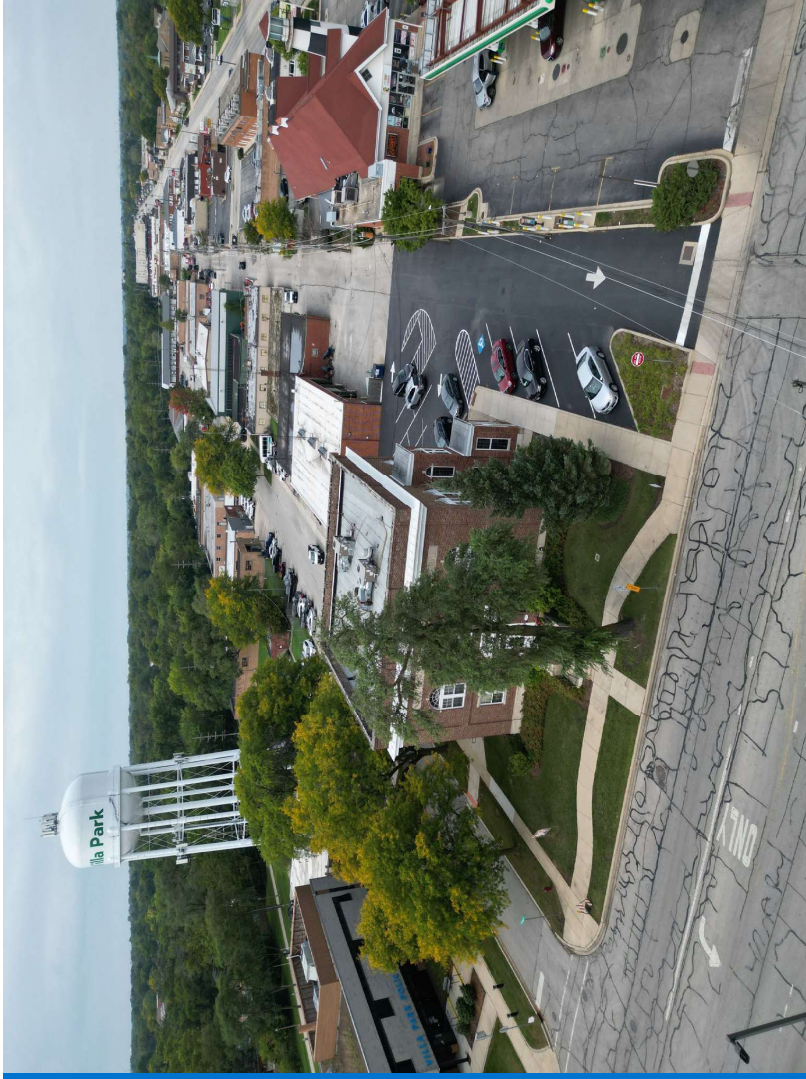
# Village Hall

- Built in 1928 (96 years old).
- \$612,311 of maintenance and repairs over the next 10 years identified.
  - Top three costs are: roof, exterior and HVAC.

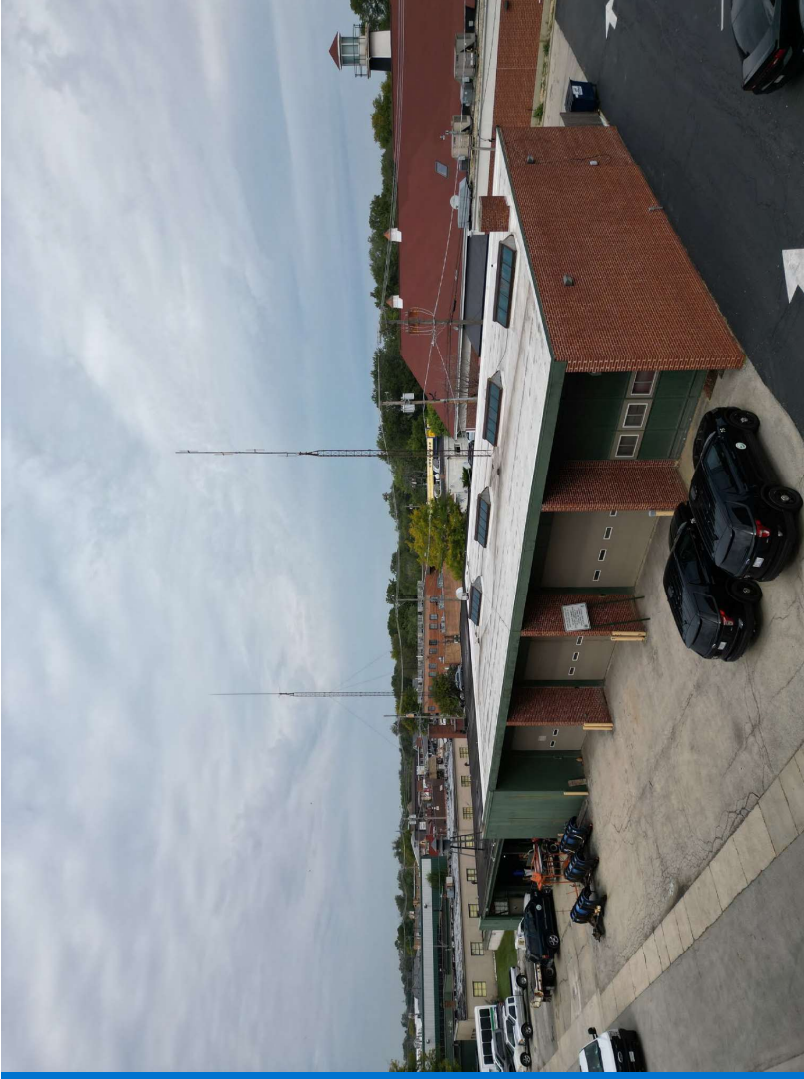
# Old Fire Station / Sign Shop

- Built in 1954 (70 years old).
- \$1,034,741 of maintenance and repairs over the next 10 years identified.
  - Top three costs are: roof, electrical and exterior.

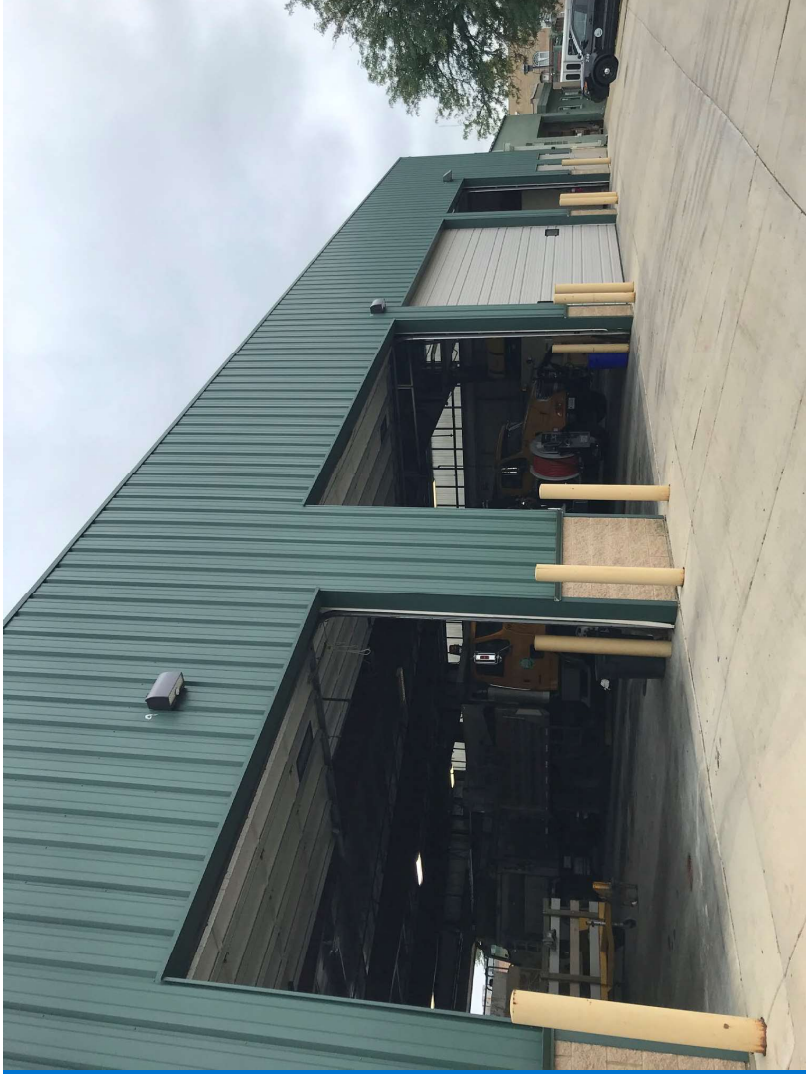
# Parks Garage

- Original built in 1980 (44 years old).
- Addition built in 2009 (15 years old).
- \$283,031 of maintenance and repairs over the next 10 years identified.
- Top three costs are: roof, interior finishes and exterior. Most of which is in the original building.

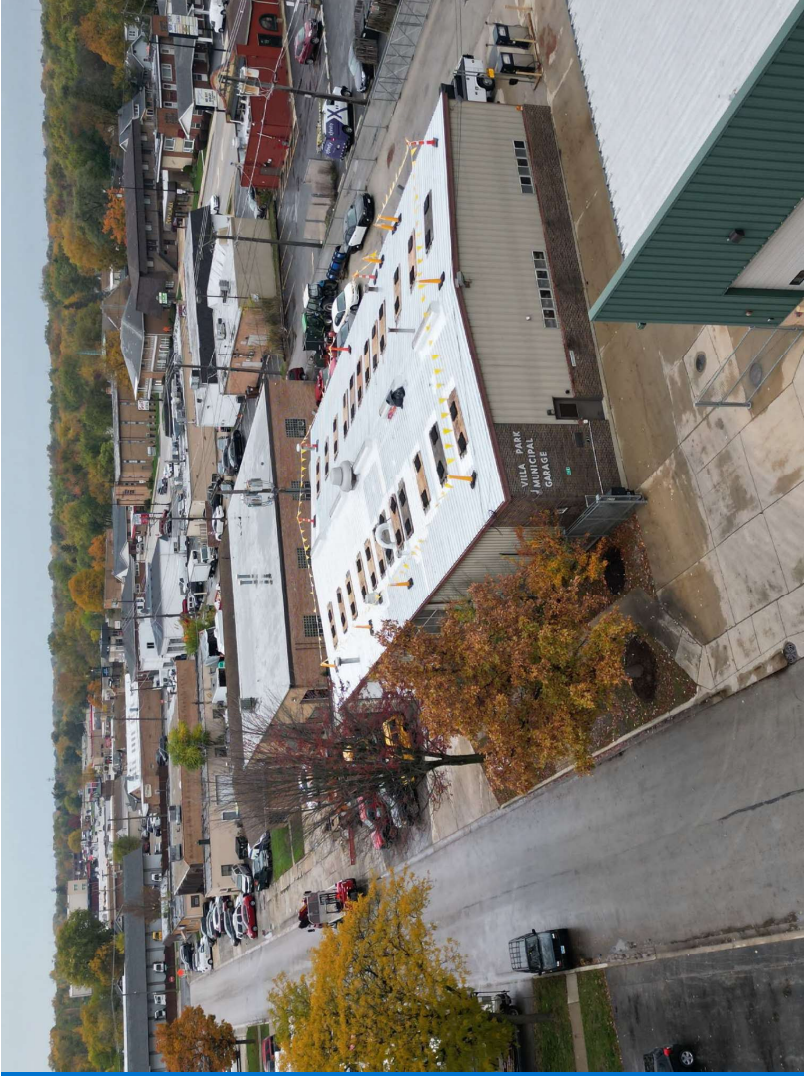
# Fleet Garage

- Built in 1969 (55 years old).
- \$581,608 of maintenance and repairs over the next 10 years identified.
  - Top three costs are: roof, exterior and electrical.

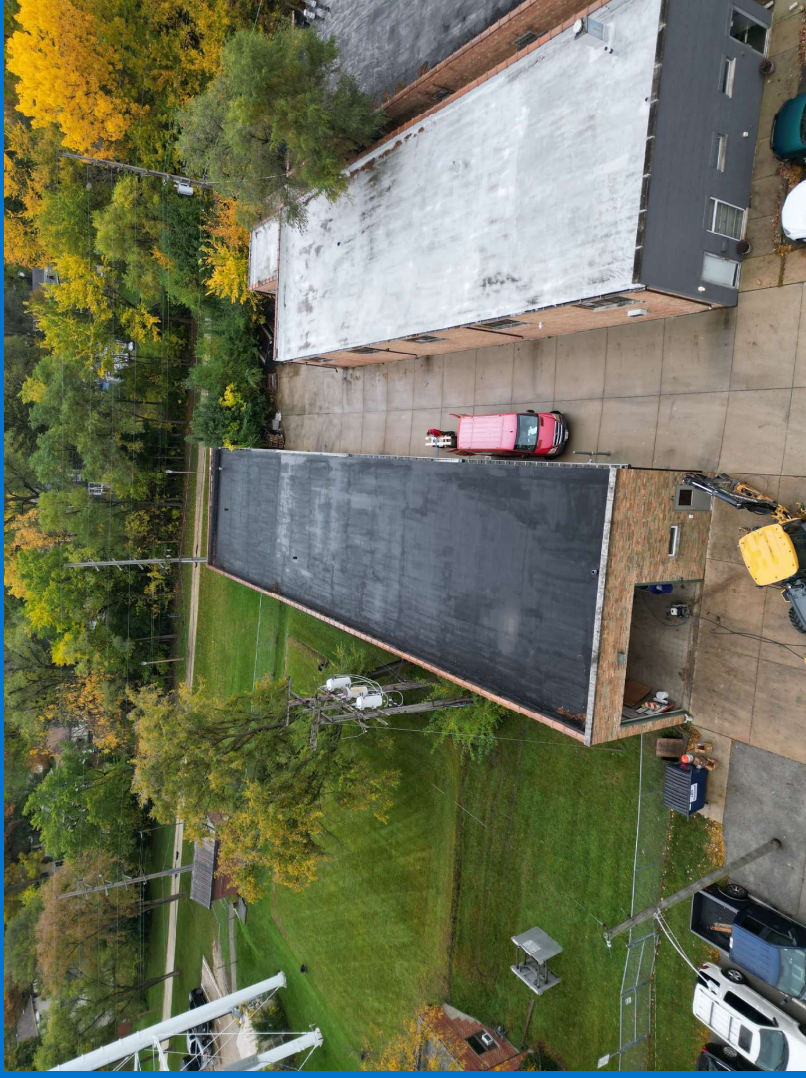
# Water / Sewer Garage

- Built in 1979 (45 years old).
- \$367,520 of maintenance and repairs over the next 10 years identified.
  - Top three costs are: roof, exterior and electrical.

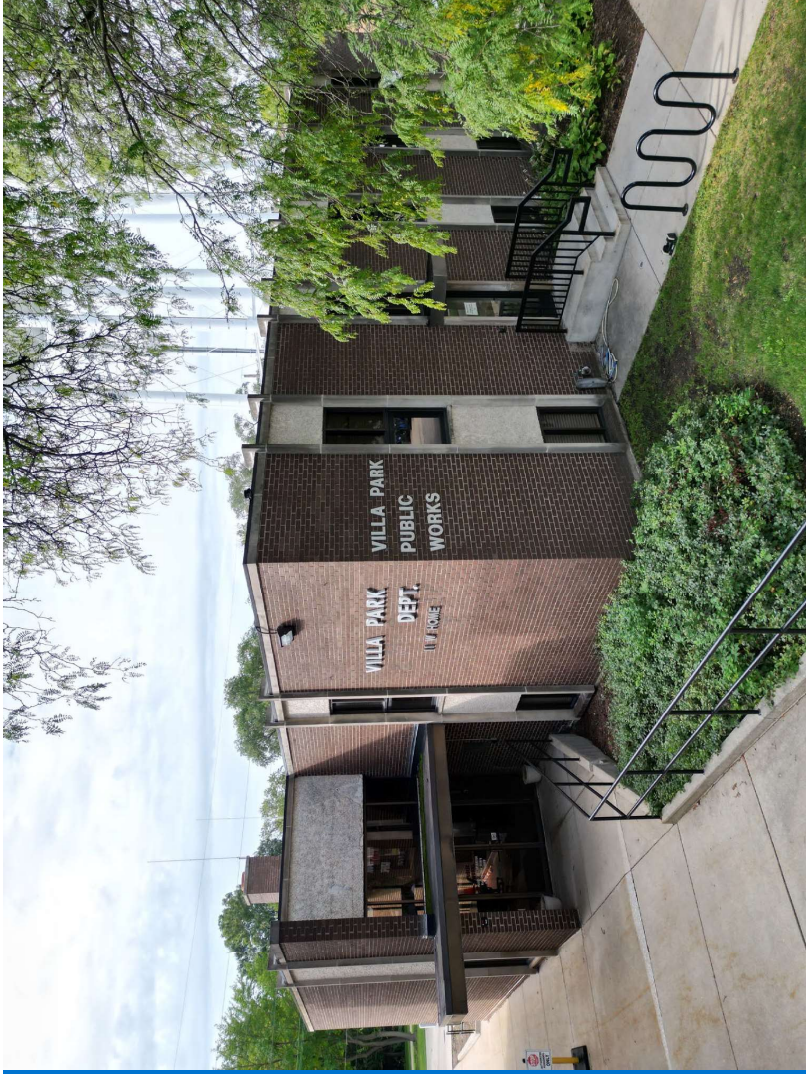
# Public Works / Community Development

- Built in 1972 (52 years old).
- \$827,157 of maintenance and repairs over the next 10 years identified.
  - Top three costs are: roof, interior finishes and electrical.

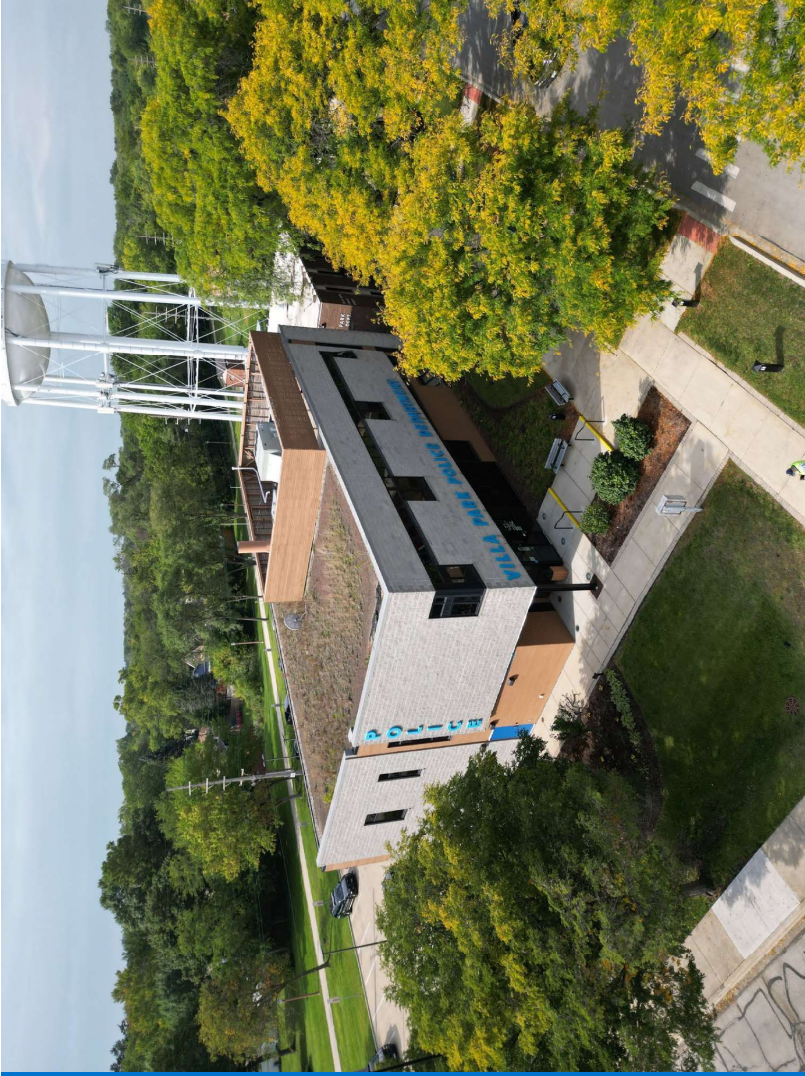
# Police Department

- Built in 2004 (20 years old).
- \$616,145 of maintenance and repairs over the next 10 years identified.
  - Top three costs are: electrical, finishes and HVAC.

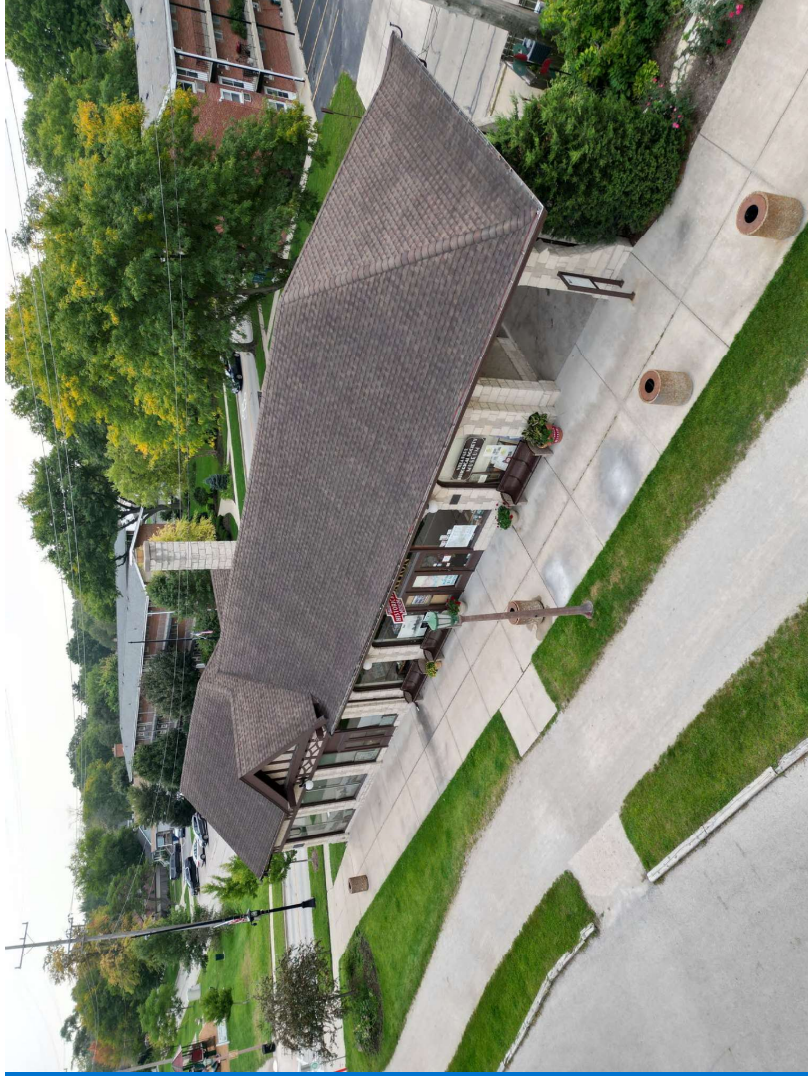
# Villa Avenue Train Station

- Built in 1929 (95 years old).
- \$325,583 of maintenance and repairs over the next 10 years identified.
  - Top three costs are: roof, electrical and exterior.

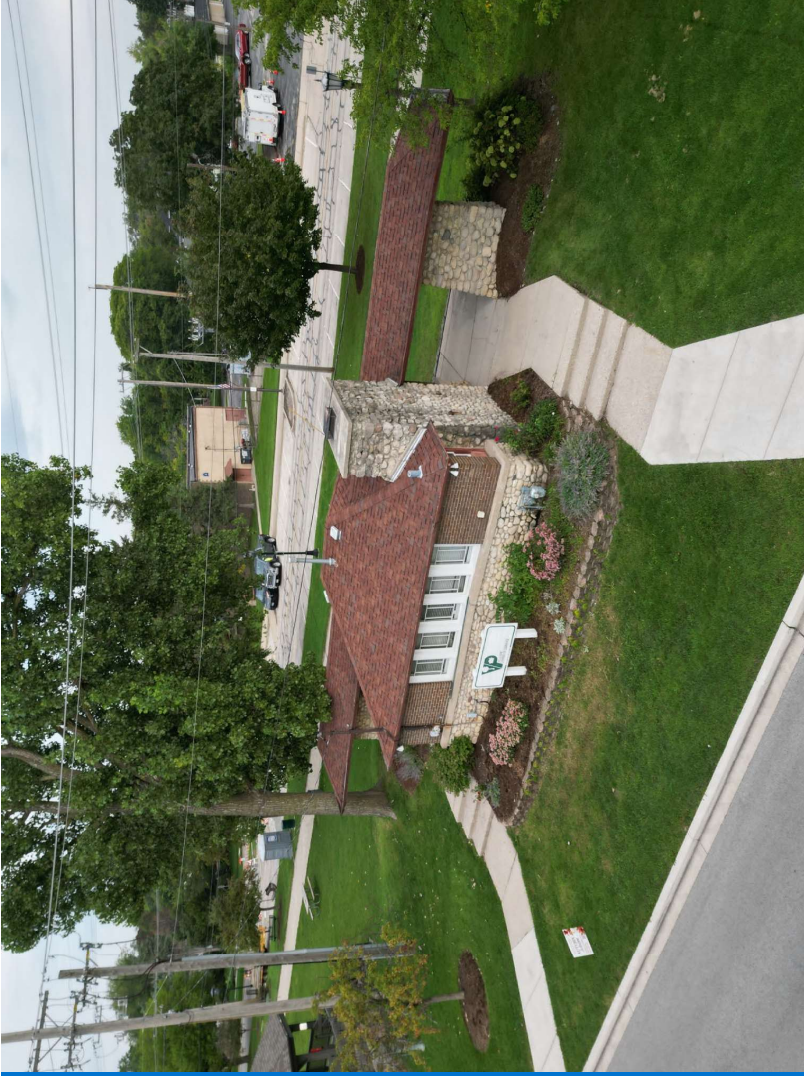
# Ardmore Station

- Built in 1910 (144 years old).
- \$232,319 of maintenance and repairs over the next 10 years identified.
  - Top three costs are: structural settling, roof, and exterior.

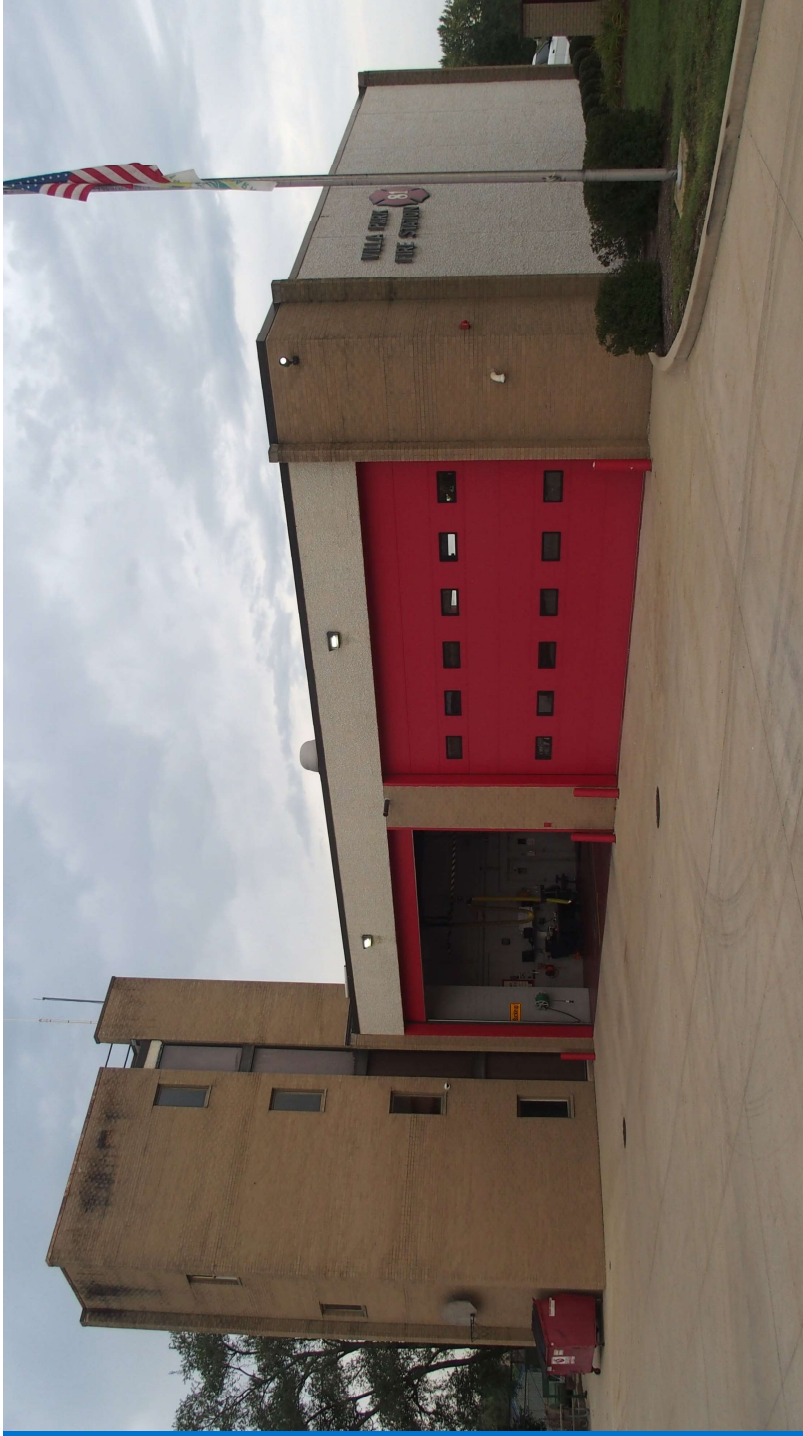
# Fire Station #81

- Built in 1975 (49 years old).
- \$576,866 of maintenance and repairs over the next 10 years identified.
  - Top three costs are: roof, exterior and HVAC.
